XRF Test Report

Client: Powderhorn Industries

Style No.: 9211
Cap with pom

Date: February 10, 2009 Standard: Lead content (CPSIA § 101)

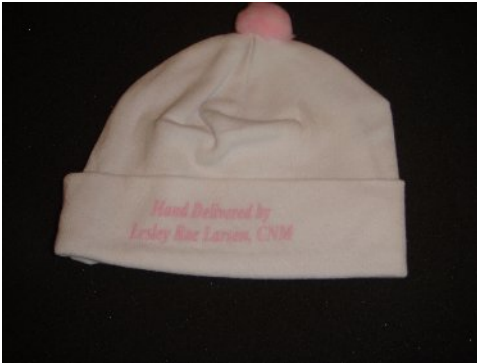
Test No.	Location/Description	Lead (Pb) (ppm)	Pass/Fail (300 ppm)	Notes
356	Material	ND < 5	Pass*	
357	Trim – pink pom	ND < 7	Pass*
